DEPARTMENT OF TRANSPORTATION

Contract #: 04-0120F4Cty: SF/ALA Rte: 80 PM: 13.2/13.9File #: 69.28**WELDING INSPECTION REPORT****Resident Engineer:**Siegenthaler, Peter**Address:** 333 Burma Road**City:** Oakland, CA 94607**Report No:** WIR-018978**Date Inspected:** 25-Dec-2010**Project Name:** SAS Superstructure**OSM Arrival Time:** 700**Prime Contractor:** American Bridge/Fluor Enterprises, a JV**OSM Departure Time:** 1900**Contractor:** Zhenhua Port Machinery Company, Ltd (ZPMC), Changxing Island **Location:** Shanghai, China

Bridge No: 34-0006**Component:** OBG/Tower**Summary of Items Observed:**

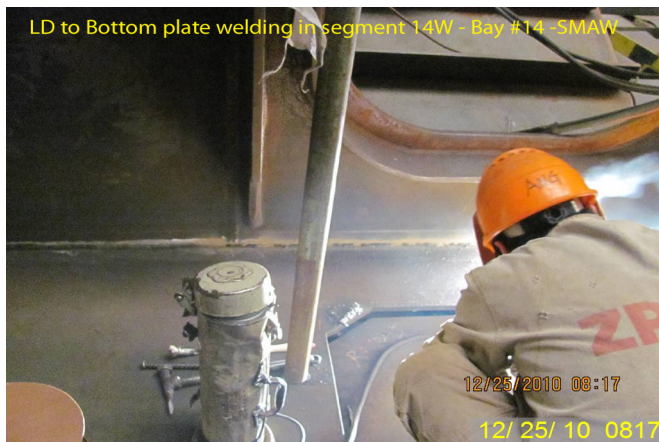
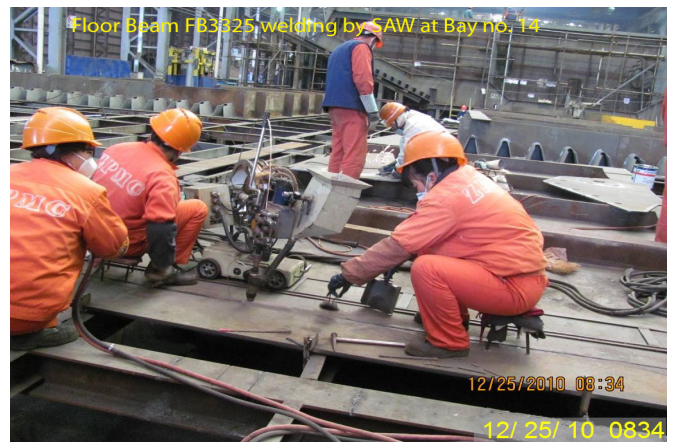
For further information see below pictures:-

Unless otherwise noted, all work observed on this date appeared to be in general compliance with the applicable contract documents.
